Commissioning Report Executive Summary

United States Diplomacy Center Owner's Project Requirements

Prepared for
General Services Administration

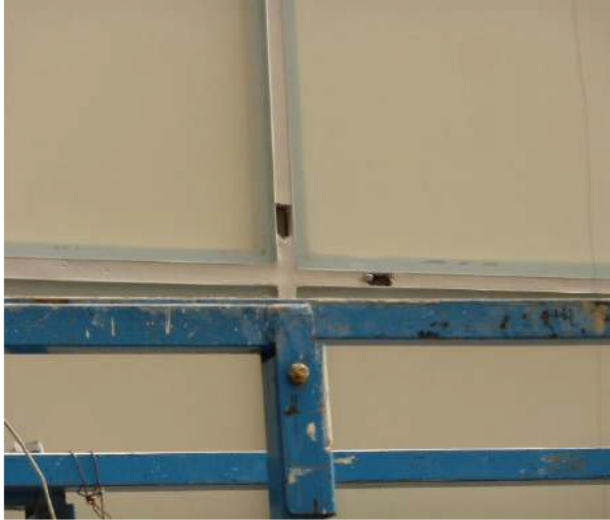
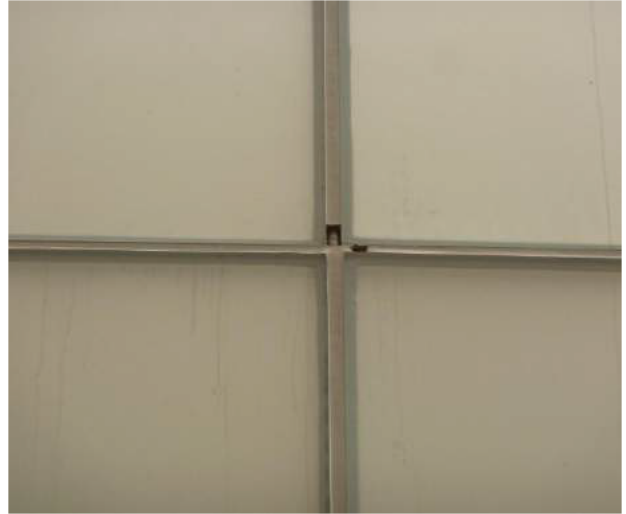
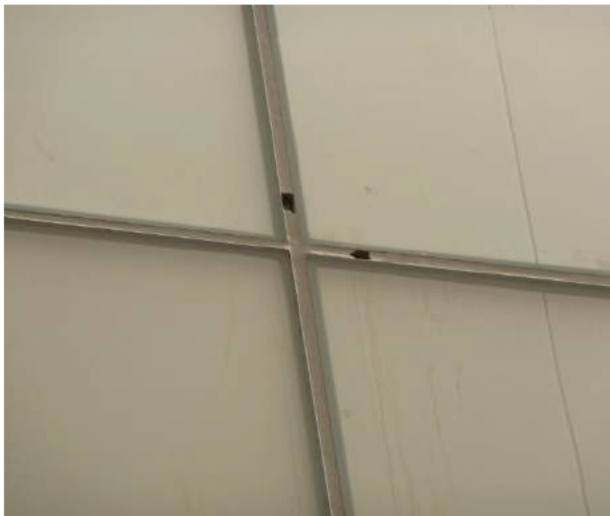
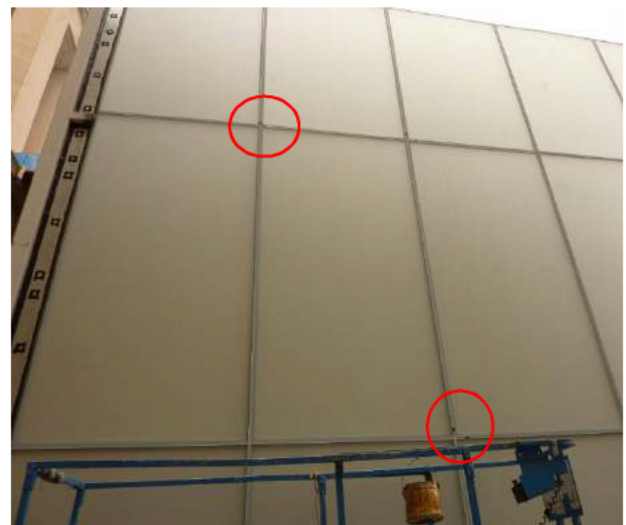
Ten separate locations of sealant pull tests were conducted to evaluate quality of sealant installation, continuity of backer rod support, thickness, and strength of adhesion. Eight of the locations were on the curtainwall assemblies and two on the upper roof skylight. No installation issues identified. Contractor appears to have done a great job preparing the surfaces and installing the sealants.

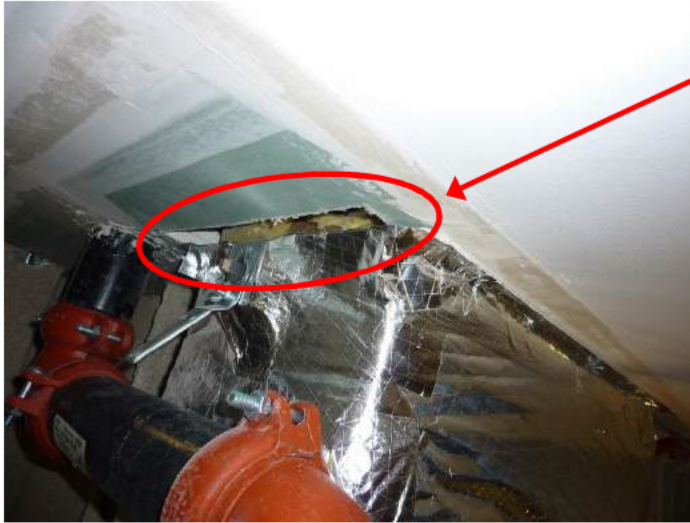
Issue #29

Above ceiling in basement.

Continuous vapor barrier not provided through wall opening.

Provide continuous insulation and vapor barrier surrounding all duct sections and through all wall penetrations.

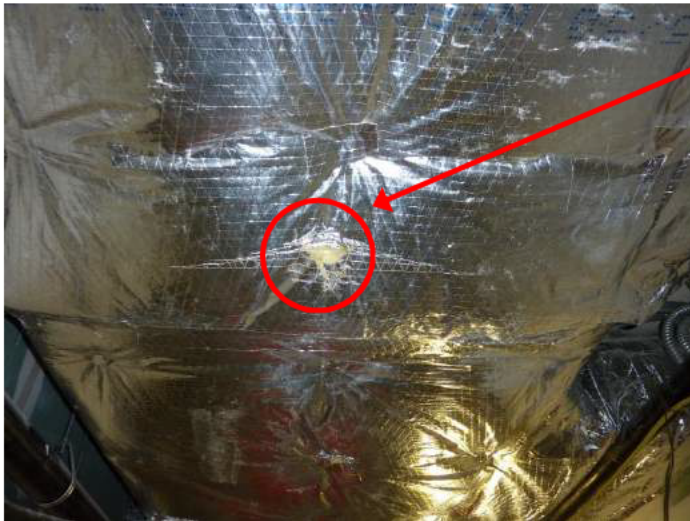
Issue #30

Above ceiling, issue is pervasive throughout project.

Vapor barrier not properly sealed.

Completely seal vapor barrier per manufacturer's requirements throughout project. Issue must be corrected prior to closing ceilings.

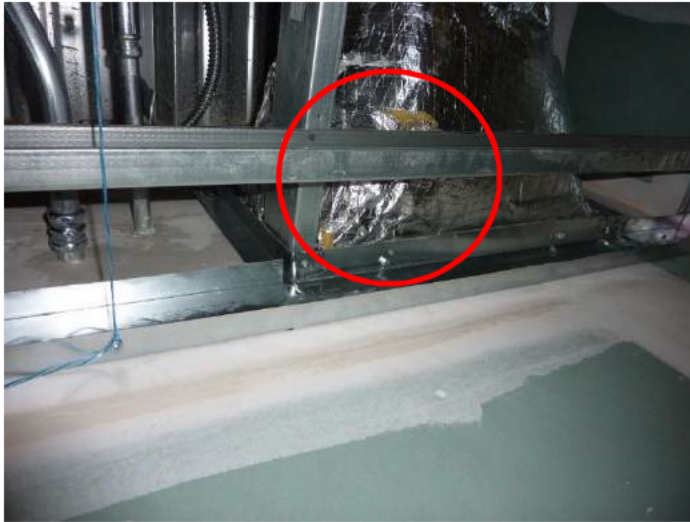
Issue #31

Above ceiling, issue is pervasive throughout project.

Vapor barrier not properly sealed.

Completely seal vapor barrier per manufacturer's requirements throughout project. Issue must be corrected prior to closing ceilings.

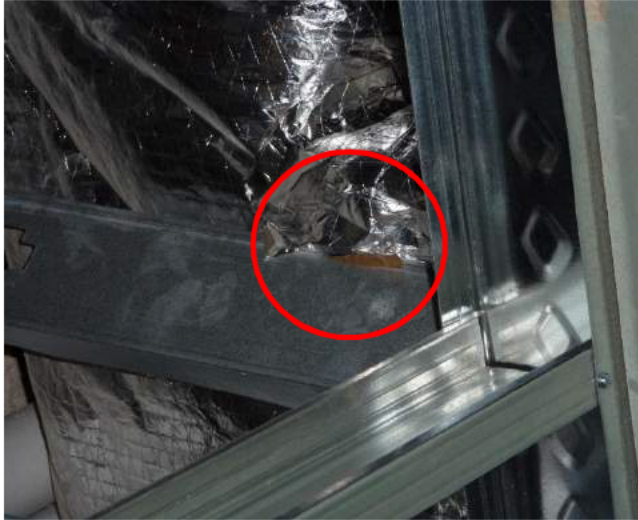
Issue #32

Above ceiling, issue is pervasive throughout project.

Vapor barrier not properly sealed.

Completely seal vapor barrier per manufacturers requirements throughout project. Issue must be corrected prior to closing ceilings.

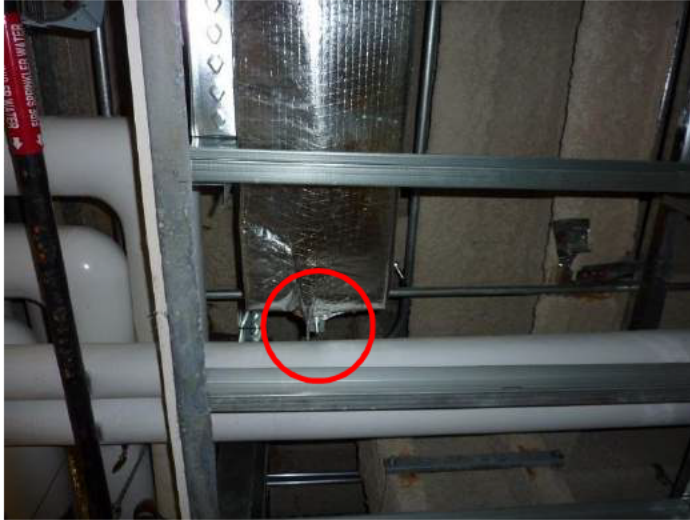
Issue #33

Above ceiling, issue is pervasive throughout project.

Support structure penetrating vapor barrier, penetrations not properly sealed.

Properly seal all vapor barrier penetrations per manufacturer's requirements throughout project. Issue must be corrected prior to closing ceilings.

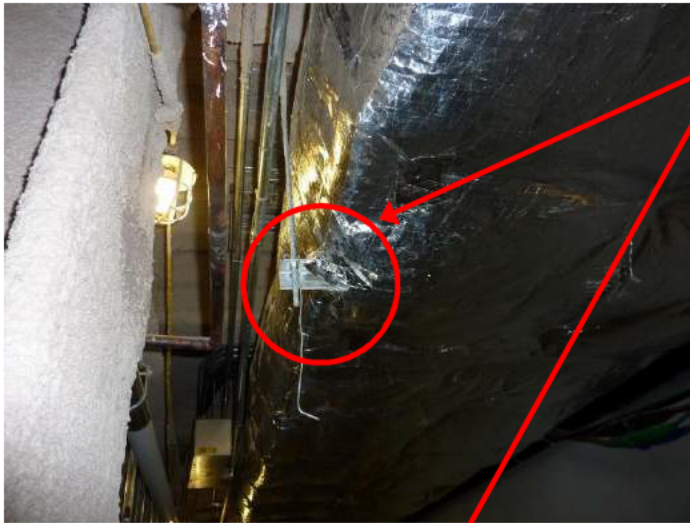
Issue #34

Above ceiling, issue is pervasive throughout project.

Support structure penetrating vapor barrier, penetrations not properly sealed.

Properly seal all vapor barrier penetrations per manufacturer's requirements throughout project. Issue must be corrected prior to closing ceilings.

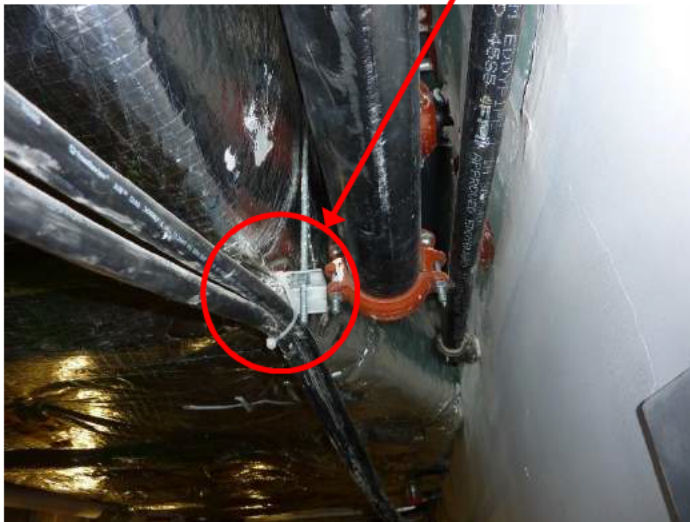
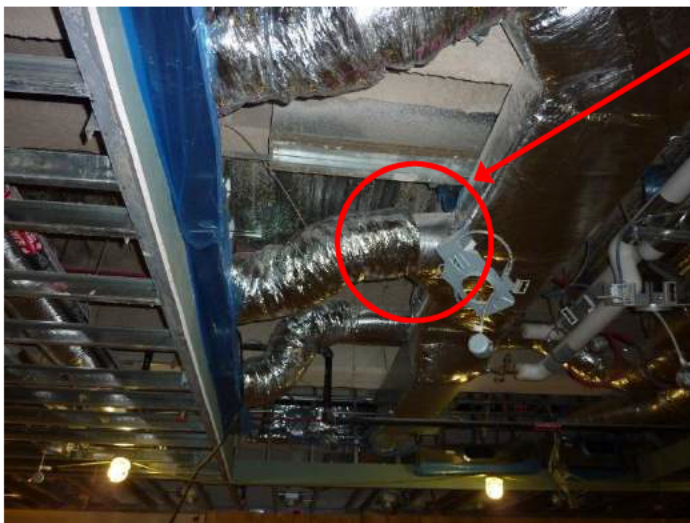
Issue #35

Flex duct connection not properly sealed.
